D
Stormwater Management Review
Prepared by Rippled Waters Engineering, LLC

STORMWATER MANAGEMENT REVIEW OF BOONTON RESERVOIR TRAIL & ENHANCEMENT PROJECT August 2019

Prepared by: Rippled Waters Engineering, LLC for Amy S. Greene Environmental Consultants, Inc.

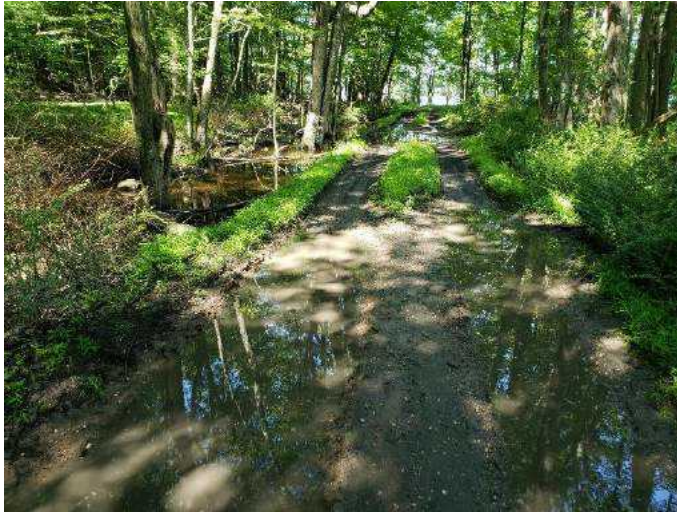
The existing roadway floods out approximately 800 feet west of the western to southern bend in Knoll Road as indicated in Photo 1 below.

Photo 1. Image of roadway flooding.

Given the localized flooding and erosion that may occur in this portion of the trail, it is anticipated that minor re-grading of the roadway may be necessary. Typically, erosion occurs on trails with grades that exceed five percent and the use of drainage measures may be required to reduce erosion and long-term maintenance of the trail. Re-grading should be completed to ensure a proper crown on the trail is maintained and that drainage is directed into the low-lying areas adjacent to the trail.

Areas of concentrated runoff may require strategic placement of rolling grade dips or rock waterbars (refer to Figure 1 below) to direct stormwater runoff across the trail without creating erosion. Rolling grade dips are used on steeper sections of trail to drain water off trails and require minimal maintenance. Rock

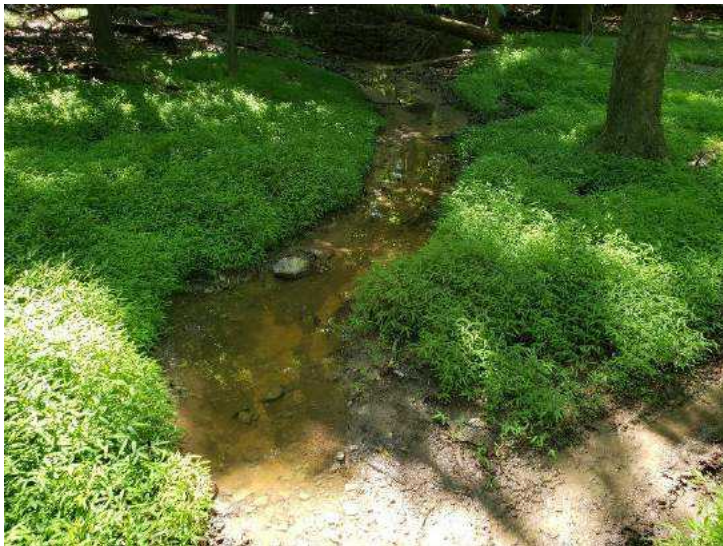
Runoff along the access road through this portion of the proposed trail concentrates as it moves downslope towards the reservoir as indicated in Photo 2 below.

Photo 2. Concentrated runoff along the access road.

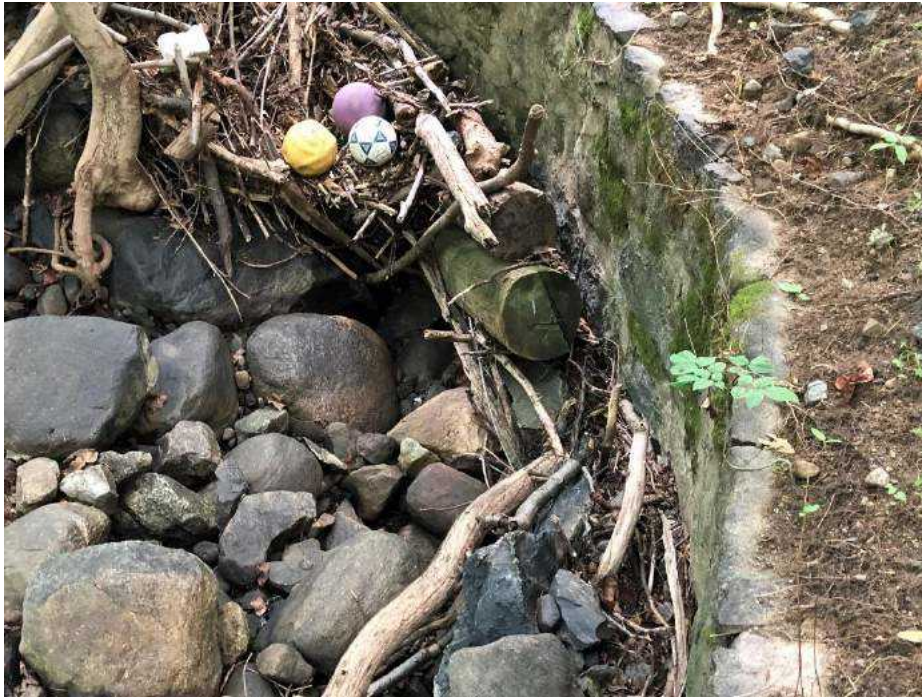
Continuing to move west there are a series of culverts with masonry end walls that serve to pass several “blue line” tributaries¹ to the reservoir beneath the existing sewer lines. An example of one of the masonry walls and culverts is shown in Photo 3 below.

Photo 3. Image of existing culvert along sewer line in the vicinity of the proposed trail.

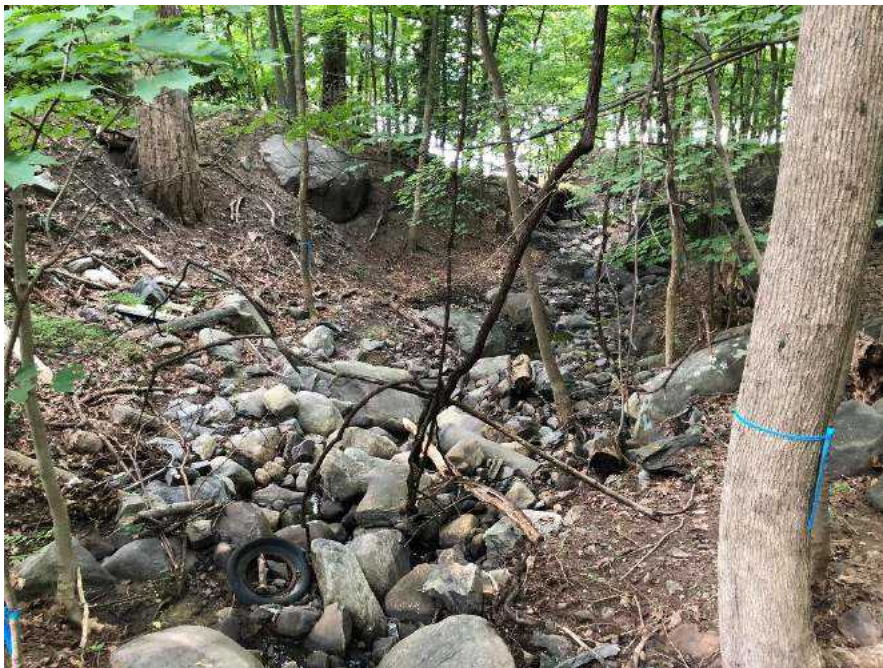
At this location, there are two culverts (approximately 36 inches in diameter). Upstream and downstream of the crossings the channels are heavily rock lined (refer to Photo 4 below) and there is evidence of significant vegetative debris and garbage accumulated both upstream and downstream of the crossings. In the case of the crossing depicted above, the culverts are virtually buried beneath the debris and boulders in the channel, which severely limits the hydraulic capacity of the pipes. It is recommended that the existing culvert crossings be cleared of all debris and large boulders when the trail is constructed and that the crossings be maintained on a regular basis as part of the ongoing trail maintenance in the future.

Photo 4. Rock lined channel upstream of sewer line crossings.

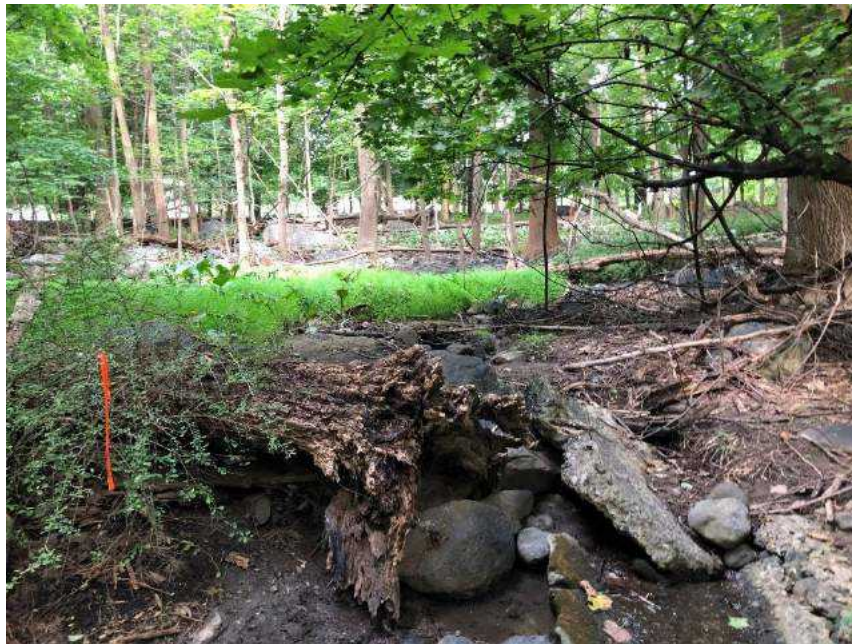
An example of the types of washouts that are evident in this area is shown in Photo 5 below. This image includes accumulated concrete debris from past attempts at stabilization. Debris accumulation and erosion are directly linked to pollutant concentration in the stormwater runoff. Phosphorus and nitrogen tend to bind with soil particles as they travel in sediment laden stormwater runoff. Turbidity is also a good indication of overall water quality as the suspended sediment load is directly linked to nutrient concentration and can also increase temperature resulting in bacteria and fecal coliform loads increasing as well.

Photo 5. Erosion and washout of soil along trail.

Areas like these will be further evaluated during future phases of the project, however, it is assumed that a combination of drainage features may be necessary to address potential washouts. These features may include waterbars, boardwalk crossings of stormwater swales, or other means necessary to control runoff across the trail in these locations and to aid in drainage in and around the trail.

The cost to repair trail washout sections is highly variable, however, it can be assumed that costs may be on the order of \$1,000 to \$5,000 per location.

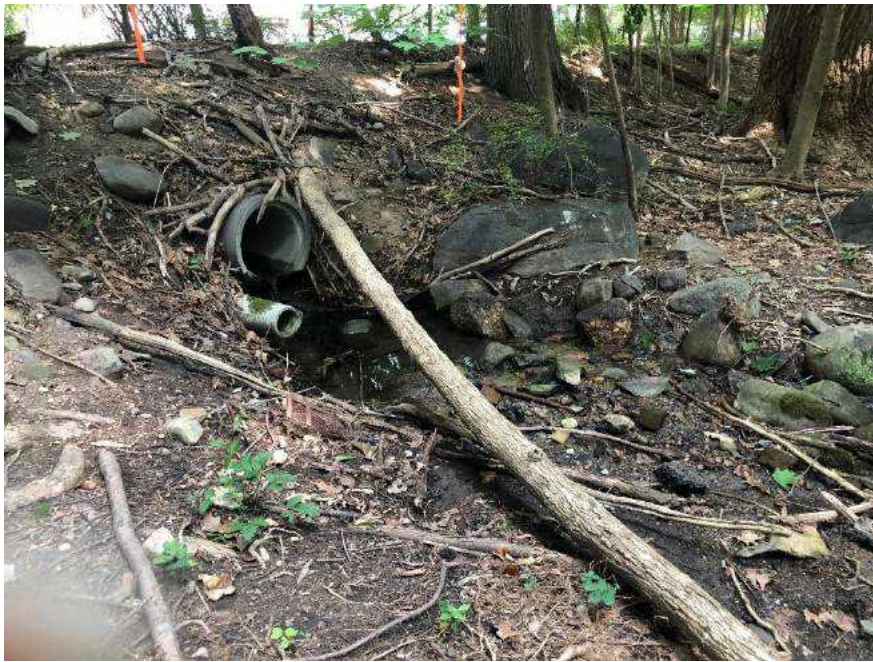
An existing stormwater outfall is located approximately 170 feet southwest of the intersection of Sherman Street and Reservoir Drive. Runoff from this discharge gradually meanders downslope until it enters Boonton Reservoir (refer to Photo 6).

Photo 6. Stormwater outfall pipe and discharge channel.

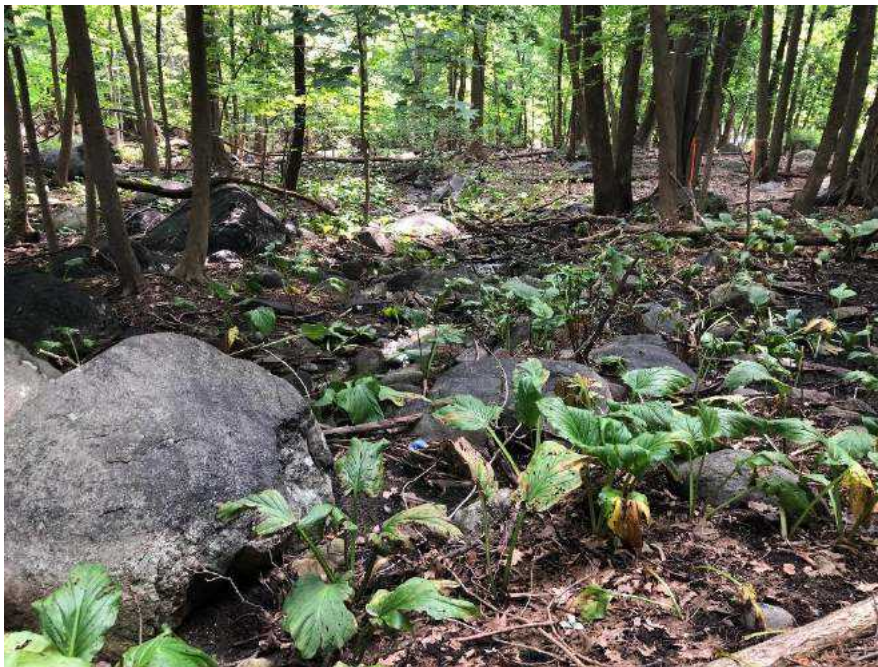
The discharge appears to be mostly stable with well-established vegetation downgradient. The pipe discharge has limited scour immediately beneath it, however, given the amount of wetland vegetation in the discharge area (refer to Photo 7) as runoff travels downslope to the reservoir it is not recommended that any stormwater mitigation measures be employed in this location. The downgradient area is stable and no erosion was noted.

Photo 7. Wetland vegetation downstream of stormwater discharge.

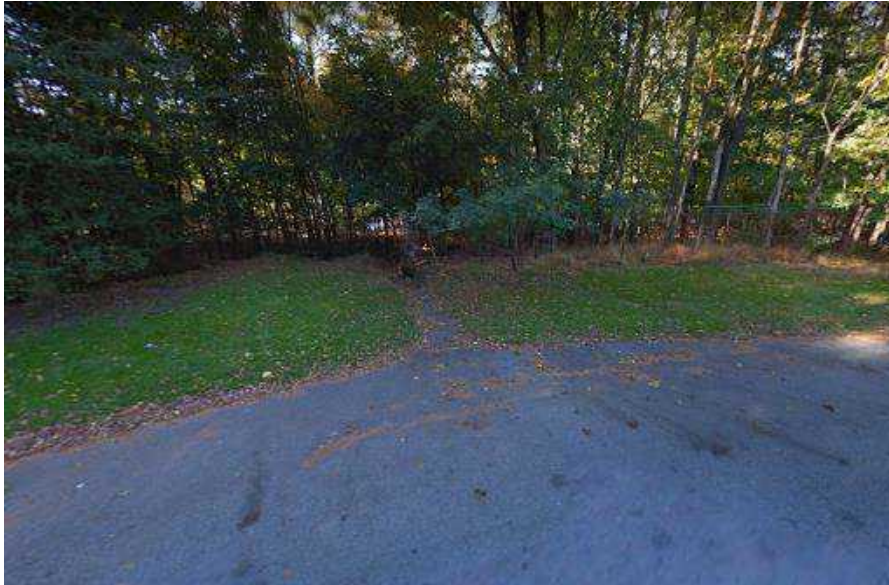
Continuing westward there are two stormwater discharges that enter the reservoir property from Reservoir Drive to the south and west of the stormwater outfall described above. Photo 8 below shows one of the asphalt swales as it leaves Reservoir Drive discharging towards the reservoir.

Photo 8. Asphalt stormwater swale from Reservoir Drive.

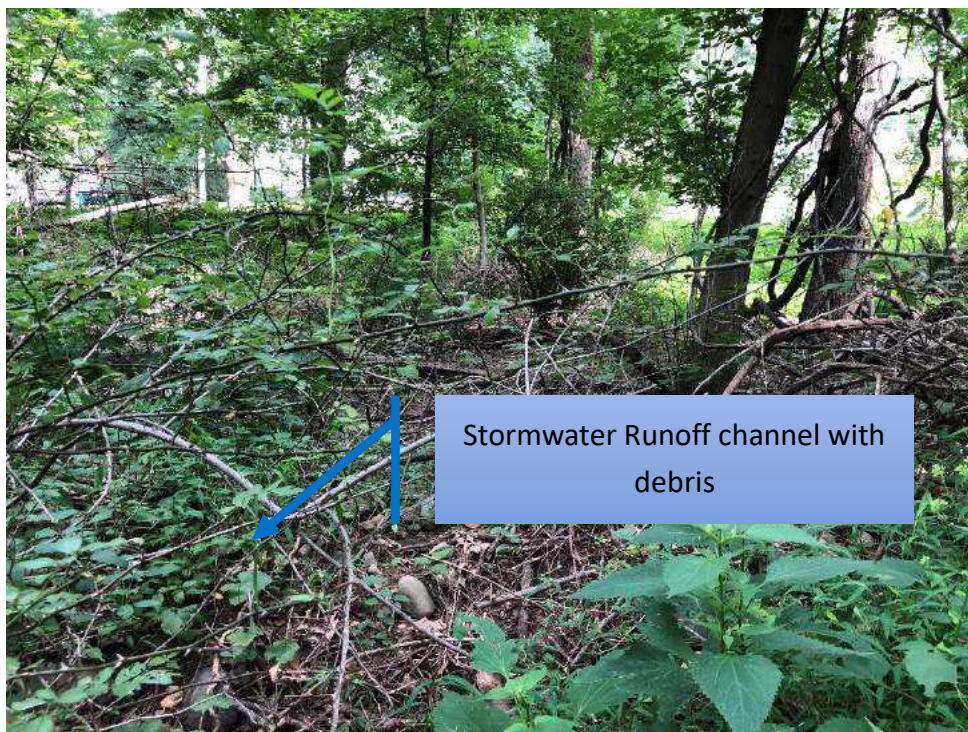
These asphalt swales terminate within the reservoir property where the runoff has created minor erosion. Photo 9 below shows the runoff channel that has been formed as a result of this runoff with heavy vegetative debris. No significant erosion was noted with these discharges.

Photo 9. Discharge from asphalt swales on Reservoir Drive.

It is recommended that stormwater mitigation for the swales be limited to that which is necessary to ensure that the trail does not wash out. Use of a swale with bio-logs may be necessary to ensure proper drainage and to improve water quality. A typical layout for the bio-log swale is shown in Figure 2 below. This concept design involves the placement of bio-logs perpendicular to flow in the channel area that are staked into the ground to a minimum depth of 12 inches. The logs can be planted and serve to retain water behind them slowing flow and reducing erosive potential and allowing suspended sediment to settle out before it discharges into the reservoir. Slowing the water also allows time for uptake by the vegetation communities and reduction of nutrient load in the system. The swale is planted with native species and the logs themselves can also be planted. Sediment will settle out behind each of the bio-logs as flow travels downstream. A retrofit like this one can be assumed to cost on the order of \$50/linear foot of swale depending on the vegetation and the diameter of biolog necessary to stabilize the swale.

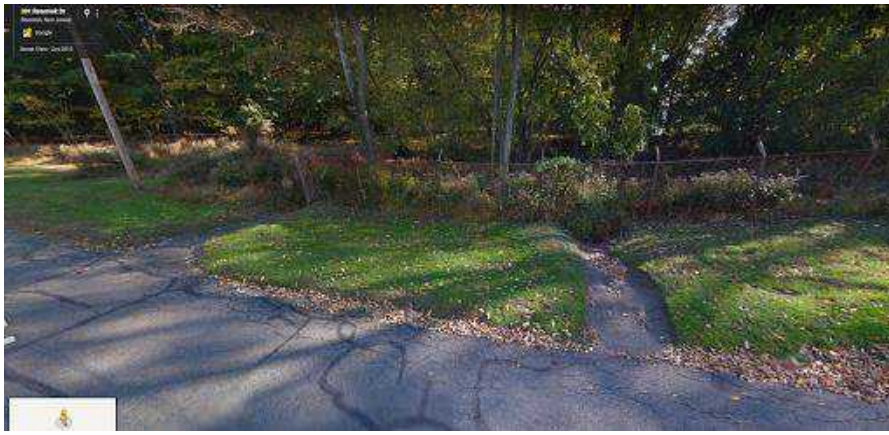
In this area of the trail, there are two more asphalt swales located south of the intersection of Boyd Street and Reservoir Drive as shown in Photo 10 below. The asphalt swales are located off the reservoir property, but the discharge from the swales at the confluence is on the reservoir property itself.

Photo 10. Asphalt swales discharge southeast of the intersection of Reservoir Drive and Boyd Street.

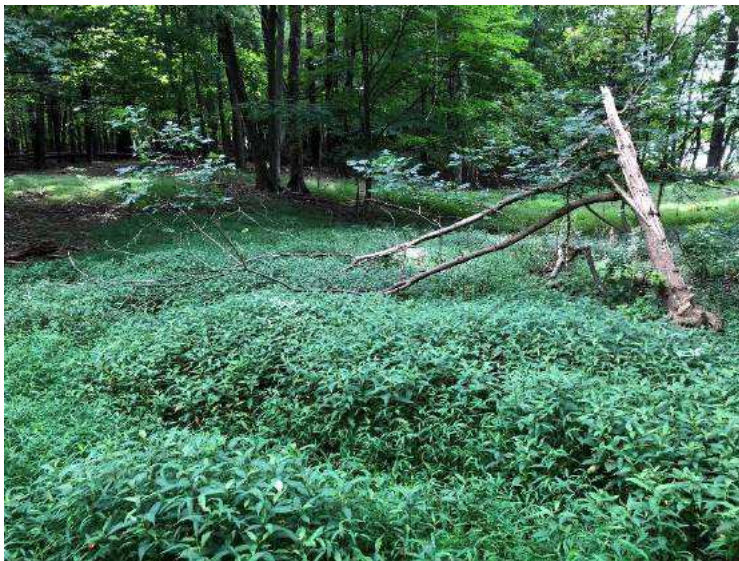
Downstream of the asphalt swales confluence is an existing vegetated swale that discharges downslope into the reservoir. The swale is dry except during rain events and has a lot of vegetative debris as shown in Photo 11 below.

Photo 11. Vegetated dry swale.

No erosion or debris was noted in the vegetated swale so no improvements are anticipated at this location for stormwater mitigation.

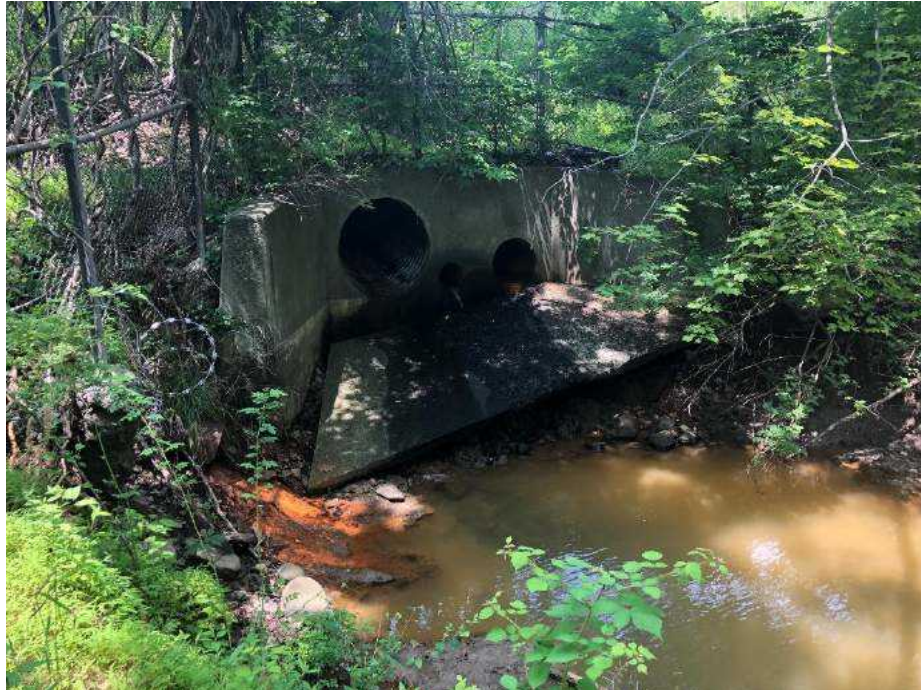
Traveling south from the Phase 2 terminus, there are two outfalls from I-287 that discharge into a cove at the western boundary of Boonton Reservoir. These discharges are large with many pipes at the outlets and are in generally poor condition. Both features will require bridge crossings and significant sediment and debris loads were observed at the outfalls. Photo 12 below indicates the level of erosion and existing condition of the existing outlet structures.

Photo 12. Existing Outfall from I-287 along significant watercourse at the northern end.

For these outfalls, the contributory watersheds are of such a size that significant volumes of water must be managed within the exit channels. The channels are regulated watercourses given their size and it is recommended that the use of stormwater bioretention cells be employed to create a series of pools at the outfall pipe locations to address the erosion and debris loads exiting the outfall pipes. Figure 4 below depicts the plan view and profile view of the potential stormwater mitigation system.

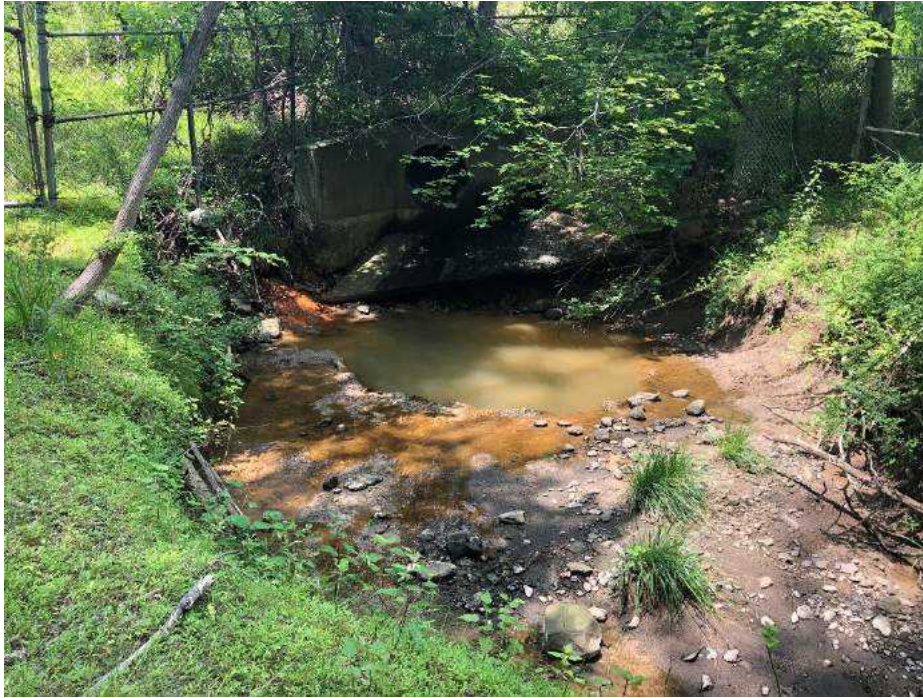
There are structural improvements necessary to stabilize the existing headwall and concrete aprons, however, the downstream channel and discharge into the reservoir is also in need of retrofit to curtail scour, erosion, and control debris as noted in Photo 13 below.

Photo 13. View of scour and erosion at outfall from I-287

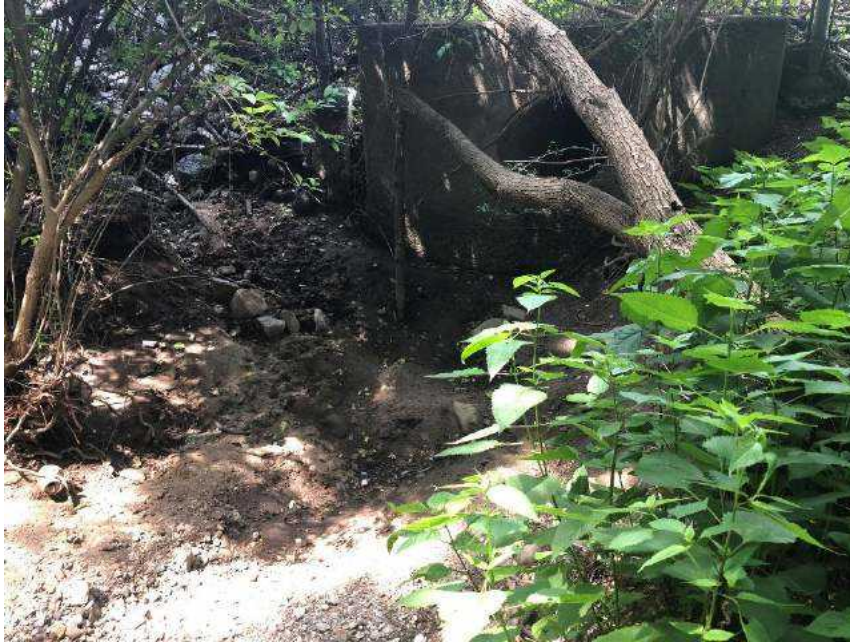
Continuing southward, another outfall from I-287 discharges into the forested area and discharges eastward into the reservoir. This outfall is in fair condition as evidenced in Photo 14 below, however, there is a significant amount of debris at this outfall and significant scour exists at the discharge point which has eroded away a portion of the soil beneath the existing fence line.

Photo 14. Outfall from I-287 (east).

Significant sedimentation and vegetated growth exist downstream of the outfall, however, runoff from the outfall is current uncontrolled as it enters the reservoir and the amount of debris and garbage is a concern for water quality. To address runoff in this location, it is anticipated that the bioretention cell stormwater mitigation measures could be employed as described for the northernmost outfalls in this area. It is not anticipated that three cells will be necessary for this location and instead perhaps a single cell may achieve the desired water quality treatment and collection point for debris.

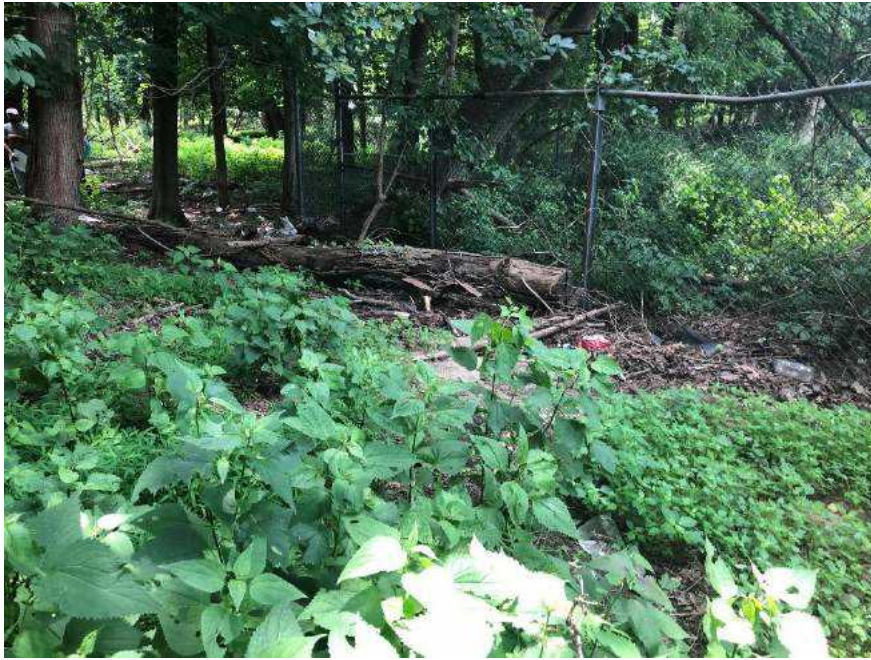
The discharge area has evidence of significant ponding and floatable debris along the fence line from I-287 as shown in Photo 15 below.

Photo 15. Debris and rack line from outfall

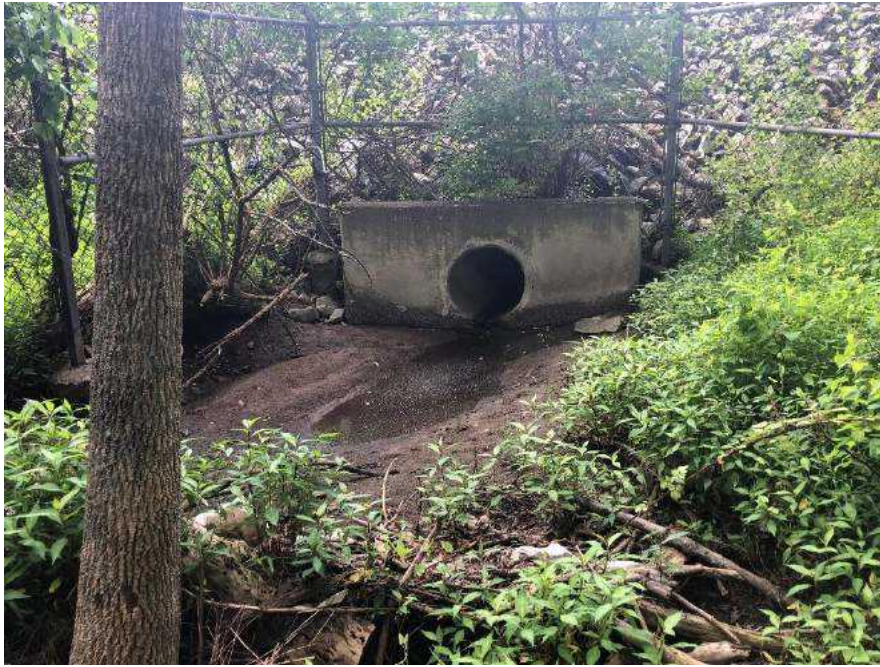
Continuing southward, another stormwater outfall exists from I-287 runoff discharging to the southeast. There is no defined swale at this location and the outfall appears to be in good condition as shown in Photo 16 below.

Photo 16. Outfall from I-287 (southeast discharge)

The discharge apron is fairly stable, however, there is no visible riprap or other conduit outlet protection visible at this location. There is a debris/rack line noted in the foreground of Photo 15, however, no erosion or defined channel exists downstream as runoff from the pipe spreads out and sheet flows across to the reservoir.

Stormwater mitigation for this outfall would be in the form of a bio-log swale as described elsewhere in this memorandum. The discharge is stable, however, there is no defined channel downstream and clearing of some existing vegetation may be necessary to construct the bio-log swale. Use of the bio-log swale will allow for more controlled management of the sediment and debris load exiting this outfall and ultimately discharging into the reservoir.

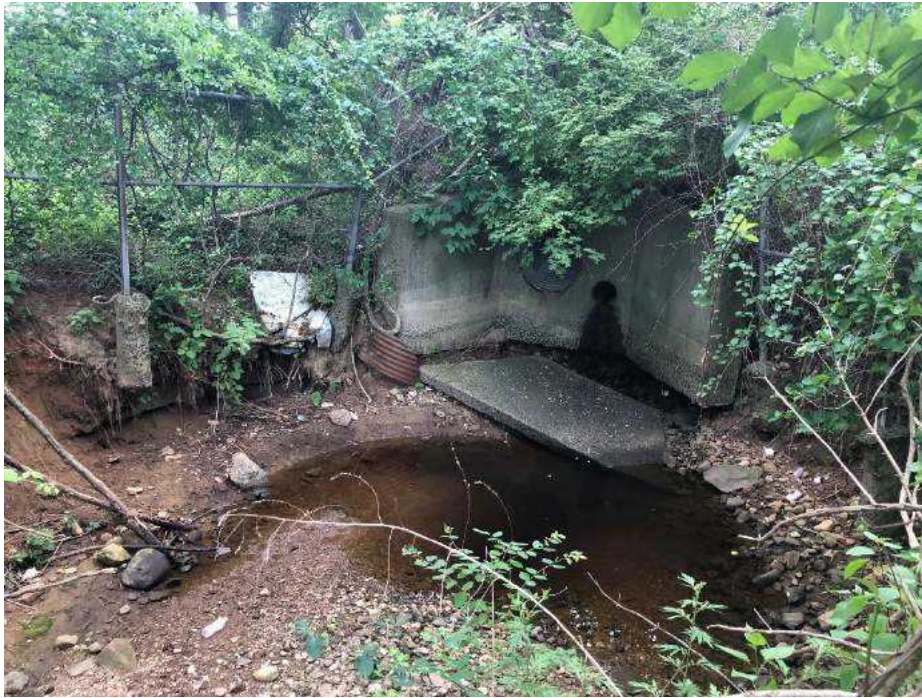
The last outfall at the southern end of I-287 within Phase 4 of the project, is in very poor condition with significant scour and erosion noted in Photo 17 below.

Photo 17. Outfall from I-287 (southernmost discharge).

The bottom of the existing headwall and apron have completely separated and the surrounding fence area has eroded to a depth of more than three feet completely exposing the footings for the chainlink fence and exposing roots of sizable trees in the forest. It can be assumed that significant sediment loads and poor water quality exists in the discharge into the reservoir from this location and that stormwater management measures will improve conditions and curtail the erosion and scour.

This outfall is one of the worst along the proposed trail and mitigation for the stormwater should be prioritized. It is anticipated that use of the bioretention cells as detailed earlier in this memorandum would be the most likely solution for this outfall. The heavy sediment load and debris load from this outfall currently is uncontrolled as runoff travels downgradient into the reservoir.

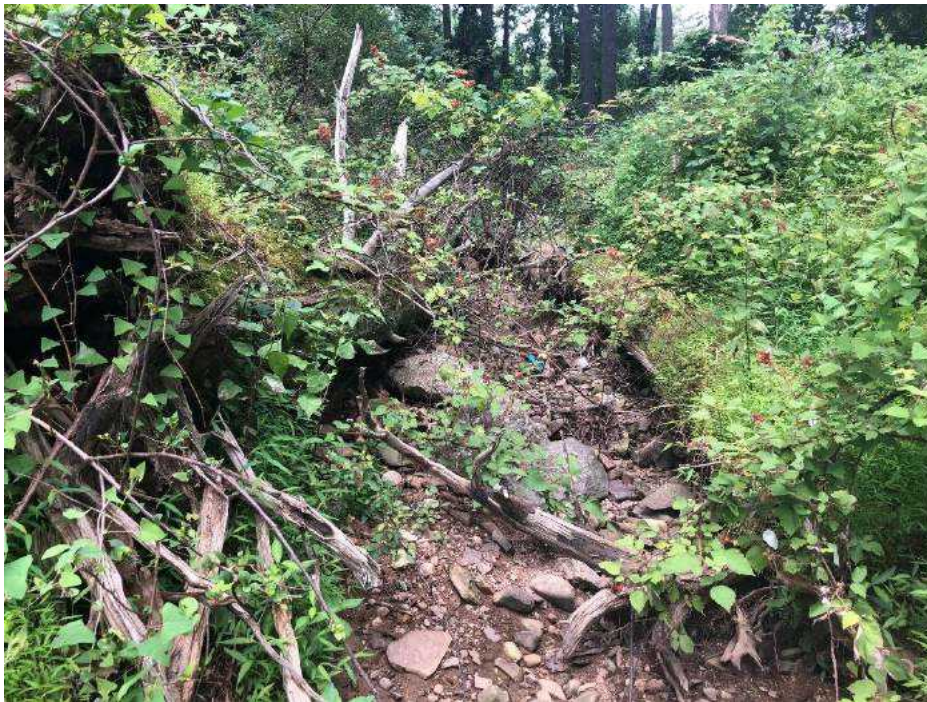
Photo 18 below provides a snapshot of the conditions downgradient from the outfall.

Photo 18. Downgradient erosion from I-287 southernmost outfall.

The stream should be stabilized using bioengineering techniques and use of large woody debris and engineered rock structures may be necessary depending on the shear stresses in the channel. The channel itself does not appear to have been constructed and instead was formed from years of uncontrolled runoff discharging from the outfall. Typical construction details for large woody debris and engineered rock structures are shown in Figure 5 below.
