D
Stormwater Management Review
Prepared by Rippled Waters Engineering, LLC

STORMWATER MANAGEMENT REVIEW OF BOONTON RESERVOIR TRAIL & ENHANCEMENT PROJECT August 2019

Prepared by: Rippled Waters Engineering, LLC for Amy S. Greene Environmental Consultants, Inc.

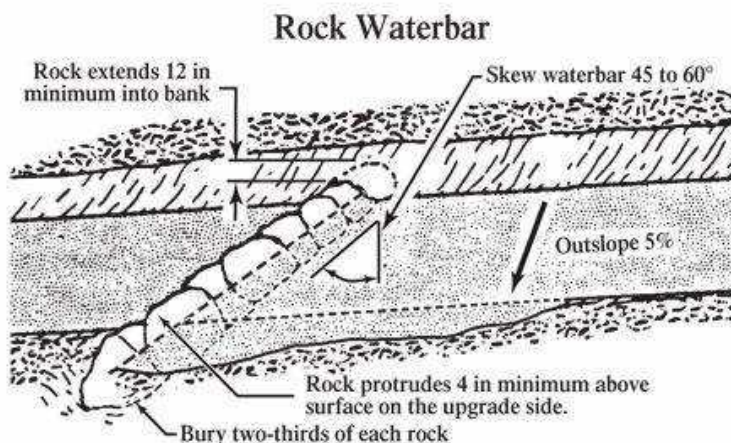
Figure 1. Typical Rock Waterbar Drainage Feature (obtained from the USDA Forest Service Trail Construction and Maintenance Notebook).

Areas of concentrated runoff may require strategic placement of rolling grade dips or rock waterbars (refer to Figure 1 below) to direct stormwater runoff across the trail without creating erosion. Rolling grade dips are used on steeper sections of trail to drain water off trails and require minimal maintenance. Rock

waterbars are structures that have the potential to clog, so care will be taken to ensure they are placed in locations that are least likely to clog. In areas where the runoff is concentrated to a point that a waterbar may not be sufficient, a culvert installation may be necessary.

Costs for waterbar installation is nominal (<\$500 per structure) while the cost for installation of culverts along the trail can be anticipated to range from \$500 to \$5,000.

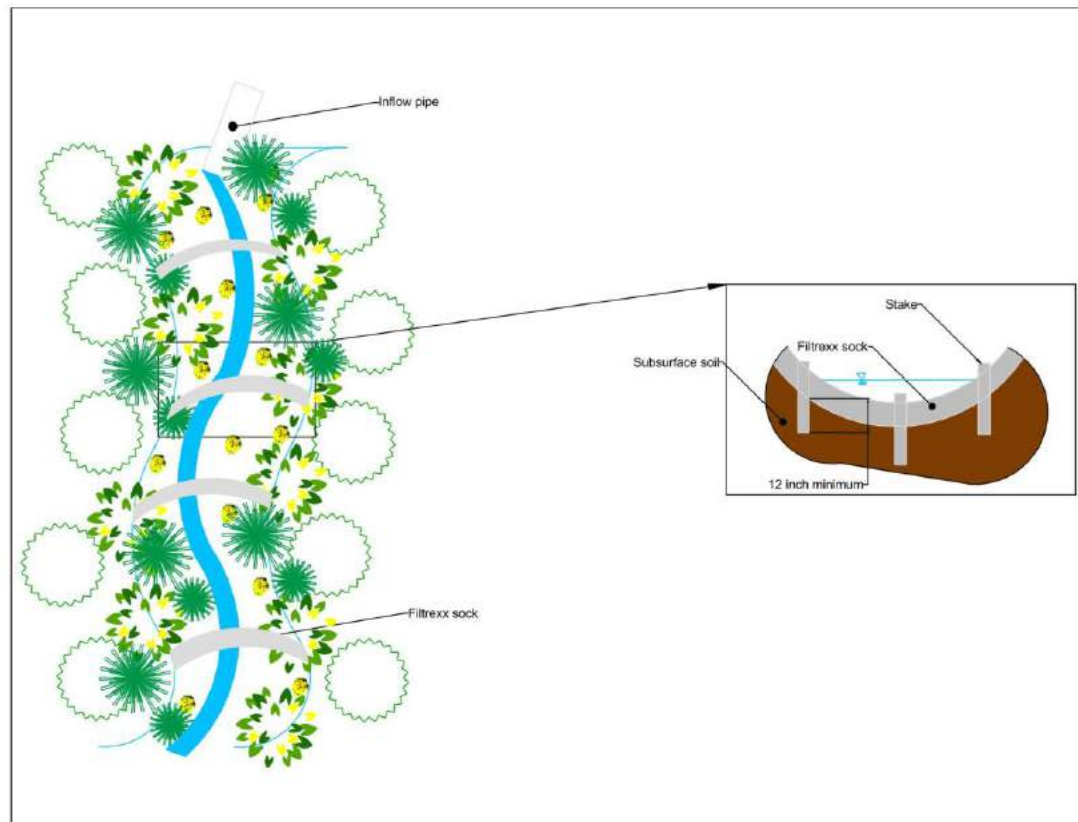
Figure 2. Bio-log swale feature

These asphalt swales terminate within the reservoir property where the runoff has created minor erosion. Photo 9 below shows the runoff channel that has been formed as a result of this runoff with heavy vegetative debris. No significant erosion was noted with these discharges.

It is recommended that stormwater mitigation for the swales be limited to that which is necessary to ensure that the trail does not wash out. Use of a swale with bio-logs may be necessary to ensure proper drainage and to improve water quality. A typical layout for the bio-log swale is shown in Figure 2 below. This concept design involves the placement of bio-logs perpendicular to flow in the channel area that are staked into the ground to a minimum depth of 12 inches. The logs can be planted and serve to retain water behind them slowing flow and reducing erosive potential and allowing suspended sediment to settle out before it discharges into the reservoir. Slowing the water also allows time for uptake by the vegetation communities and reduction of nutrient load in the system. The swale is planted with native species and the logs themselves can also be planted. Sediment will settle out behind each of the bio-logs as flow travels downstream. A retrofit like this one can be assumed to cost on the order of \$50/linear foot of swale depending on the vegetation and the diameter of biolog necessary to stabilize the swale.

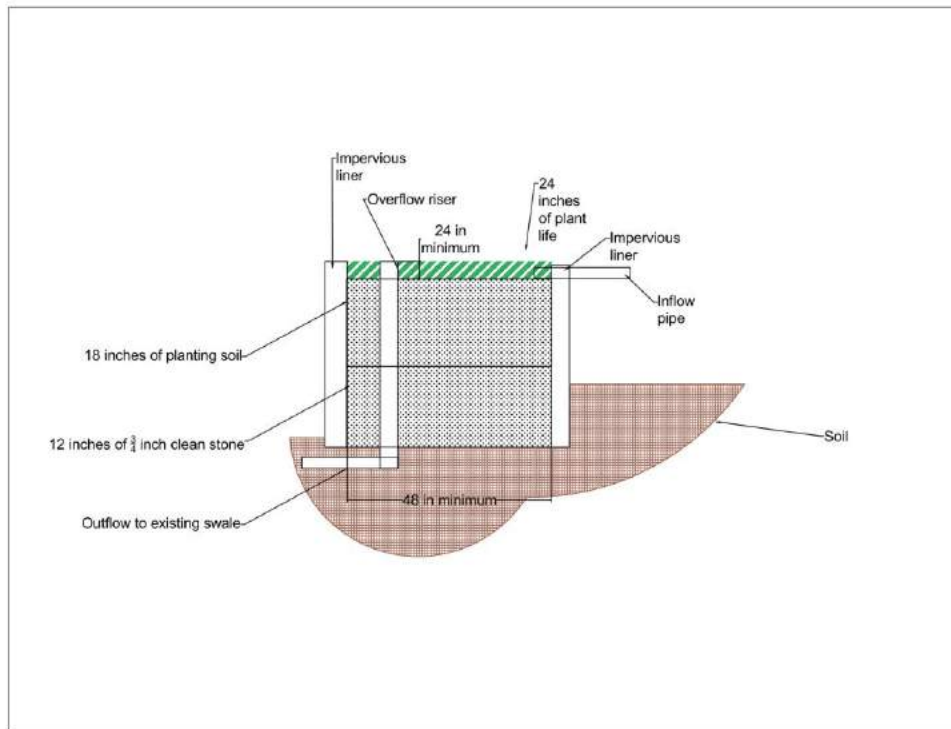
Figure 3. Biofilter cell cross-section view.

Immediately southeast of the existing pedestrian bridge across the Boonton Reservoir, there is a stormwater outlet into the reservoir which collects runoff from County Route 511. This area is susceptible to a heightened sediment and debris load given its proximity to businesses and the busier roadway. As such, it may be a candidate for retrofit, however, space at this location is limited. Use of the bio-log swale as described above may be an option at this location or alternatively, use of a biofilter cell may be more appropriate depending on the frequency of debris loads. The design concept for the biofilter cell is shown in Figure 3 below.

The biofilter cell consists of a mulch bed over a combination of planting soil and clean stone that serves as a filter over the native soils. If the native soils are such that they can infiltrate than no underdrain is necessary. Alternatively, the system is lined and use of a perforated pipe that serves as an underdrain for the cell is used. The biofilter cell system filters pollutants from the runoff before discharge into the reservoir and also serves to collect floatable and vegetative debris at the surface and would serve to improve water quality. Runoff from large rain events (greater than a 2-year recurrence interval) overflows from the cell and discharges. At the southern terminus of Phase 2, there is an existing stormwater gully that will require a trail crossing in the form of a boardwalk or bridge, however, no erosion was noted at this location so no stormwater mitigation measures are proposed.

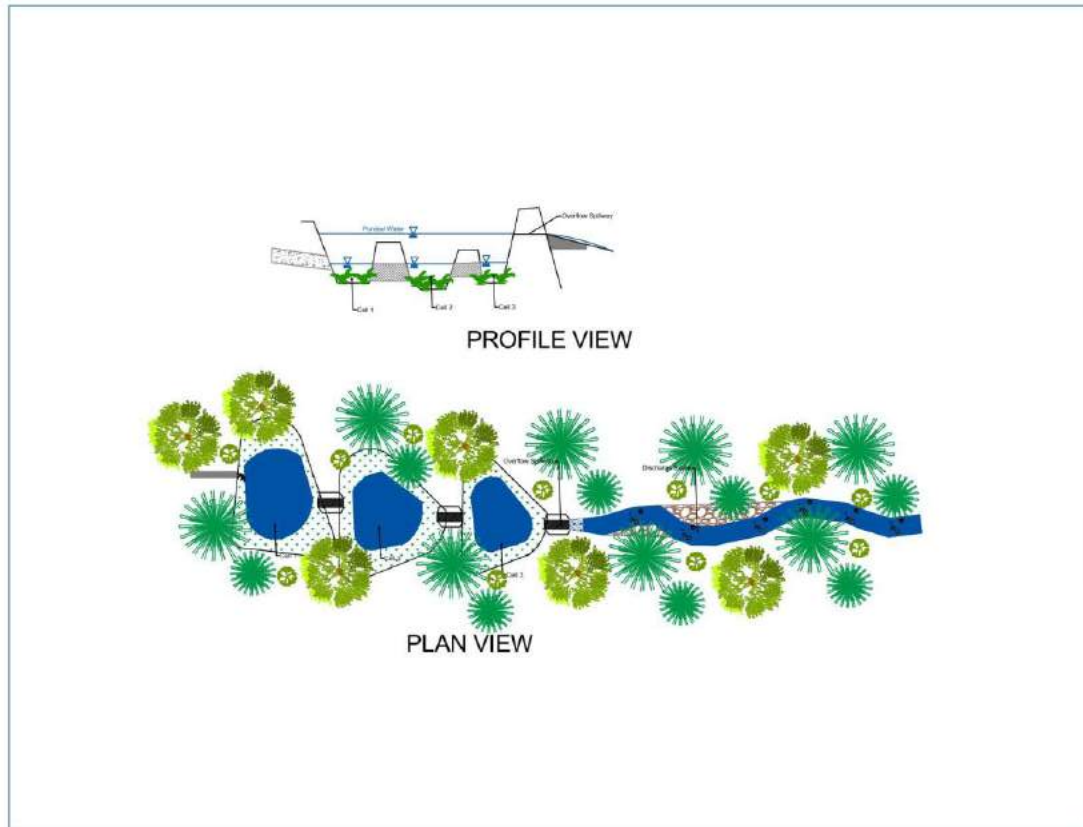
Figure 4. Bioretention cells and swale system

There are structural improvements necessary to stabilize the existing headwall and concrete aprons, however, the downstream channel and discharge into the reservoir is also in need of retrofit to curtail scour, erosion, and control debris as noted in Photo 13 below.

For these outfalls, the contributory watersheds are of such a size that significant volumes of water must be managed within the exit channels. The channels are regulated watercourses given their size and it is recommended that the use of stormwater bioretention cells be employed to create a series of pools at the outfall pipe locations to address the erosion and debris loads exiting the outfall pipes. Figure 4 below depicts the plan view and profile view of the potential stormwater mitigation system.

The bioretention cells serve as collection points for sediment and debris and allow for easier cleanout of accumulated materials as they exit the pipes and provide water quality treatment for stormwater runoff. The cells also serve to control stormwater runoff discharge rate and volume and promote infiltration and vegetation uptake of stormwater removing pollutants from the system. Further, these cells serve to slow the water down and dissipate energy as it flows downgradient. Up to three cells may be necessary to dissipate the energy and collect the debris prior to discharge into a vegetated swale conveyance downstream. The system will serve to provide filtration of water associated with small rain events (less than a 2-year recurrence interval) and retention of rain events up to the 10-year recurrence interval with runoff from larger events discharging via an overflow spillway into the downstream swale. The entire system will be planted with native vegetation.

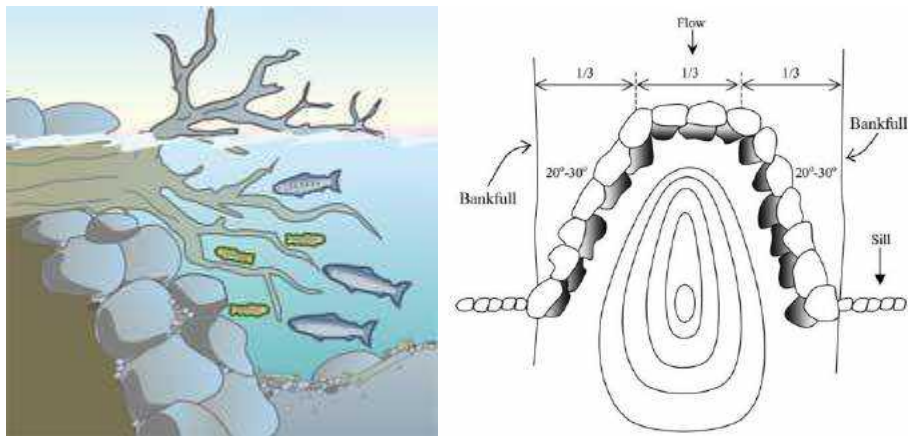
Figure 5. Large Woody Debris detail (from King County website) and Rock Vane detail (Rosgen).

The bottom of the existing headwall and apron have completely separated and the surrounding fence area has eroded to a depth of more than three feet completely exposing the footings for the chainlink fence and exposing roots of sizable trees in the forest. It can be assumed that significant sediment loads and poor water quality exists in the discharge into the reservoir from this location and that stormwater management measures will improve conditions and curtail the erosion and scour.

The stream should be stabilized using bioengineering techniques and use of large woody debris and engineered rock structures may be necessary depending on the shear stresses in the channel. The channel itself does not appear to have been constructed and instead was formed from years of uncontrolled runoff discharging from the outfall. Typical construction details for large woody debris and engineered rock structures are shown in Figure 5 below.

Costs for addressing the scour and installation of woody debris and vane structures in the downstream discharge for a system like this would be on the order of \$5,000 to \$30,000 to install.
